BIG BEAVER DAM

PHASE I INSPECTION REPORT
NATIONAL DAM INSPECTION PROGRAM

MICHAEL BAKER, JR., INC.

February 1980

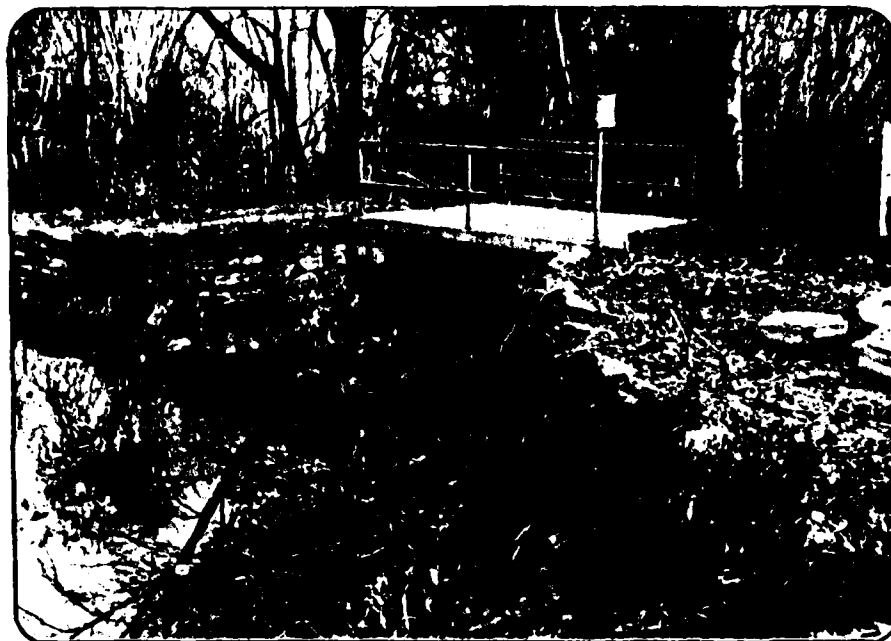
- c. Appurtenant Structures - The spillway channel is constructed of cut stone. Some of the stones appeared to be loose. The approach channel to the spillway has some silt and trash at the entrance of the spillway but is reportedly periodically cleaned by the owner (see Photo No. 1). There is some debris and fallen riprap located in the discharge channel. At times of high flows, minor erosion of the toe of the downstream slope may occur (see Photo 3). (Note: After reviewing the

PHOTO 1. View of Entrance to Spillway

- 3) All loose stones in the spillway structure should be secured, possibly by grouting (pointing) the voids. In addition, the walls of the chute channel should be repaired where the stones have fallen into the channel.
